Estimation of Pier Scour and Channel Stability for Highway Crossings of the Red River in Louisiana

TECHNICAL REPORT NO. 67A

J. Josh Gilbert and Paul A. Ensminger

1999

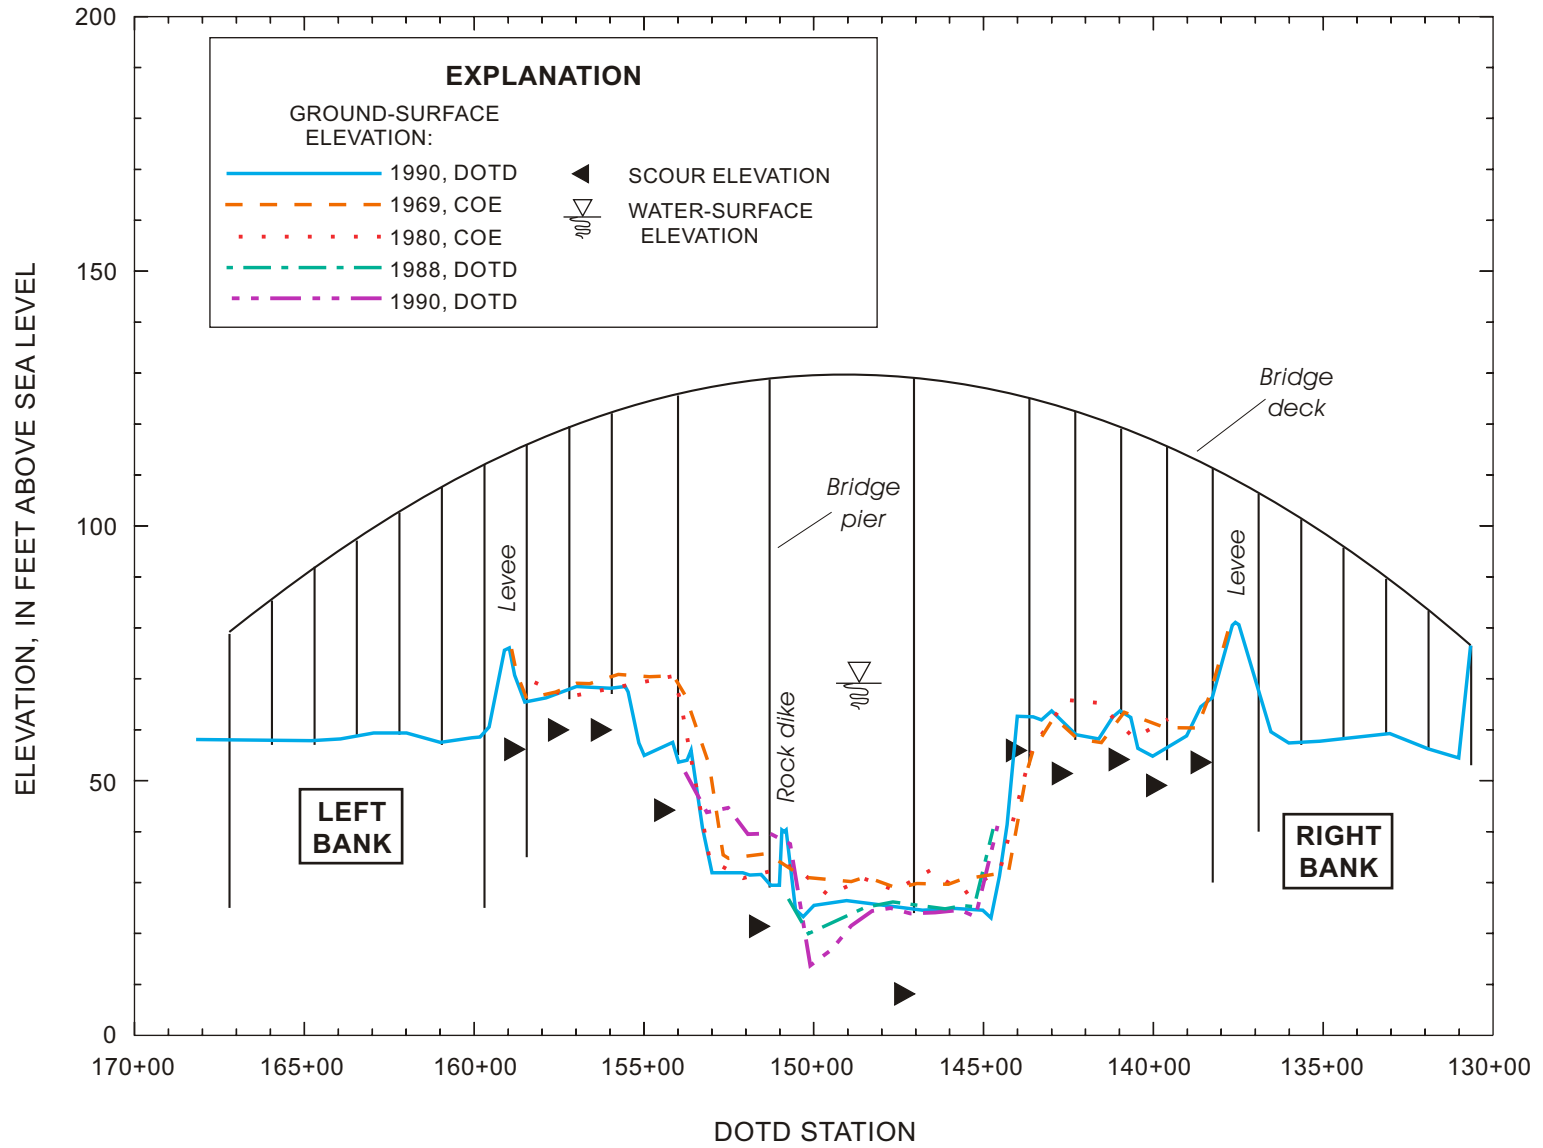
Figure 4. Comparative cross sections and pier-scour estimates at Louisiana Highway 107 crossing near Moncla, Louisiana.

A comparison of the historical hydrographic information in the vicinity of Moncla using the hydrographic survey of 1969 and 1990 indicates the river bed degraded about 5 ft during the 20-year period. Additional cross-sectional information was taken from limited hydrographic surveys performed by DOTD. A comparison of the DOTD surveys of 1988 and 1990 (fig. 4) indicates channel-bed elevations in 1990 were approximately 5 ft lower at one location but were unchanged at other locations. The observed channel-bed fluctuations could result from a combination of the normal dynamic behavior of the river channel over a wide range of streamflows, and the local effect of the rock dike on the channel cross section (fig. 4). Although local scouring, filling, and transient bed forms alter channel depth periodically, the long-term minimum channel-bed elevation may be relatively stable at 25 ft above sea level, and neither aggrading nor degrading substantially.

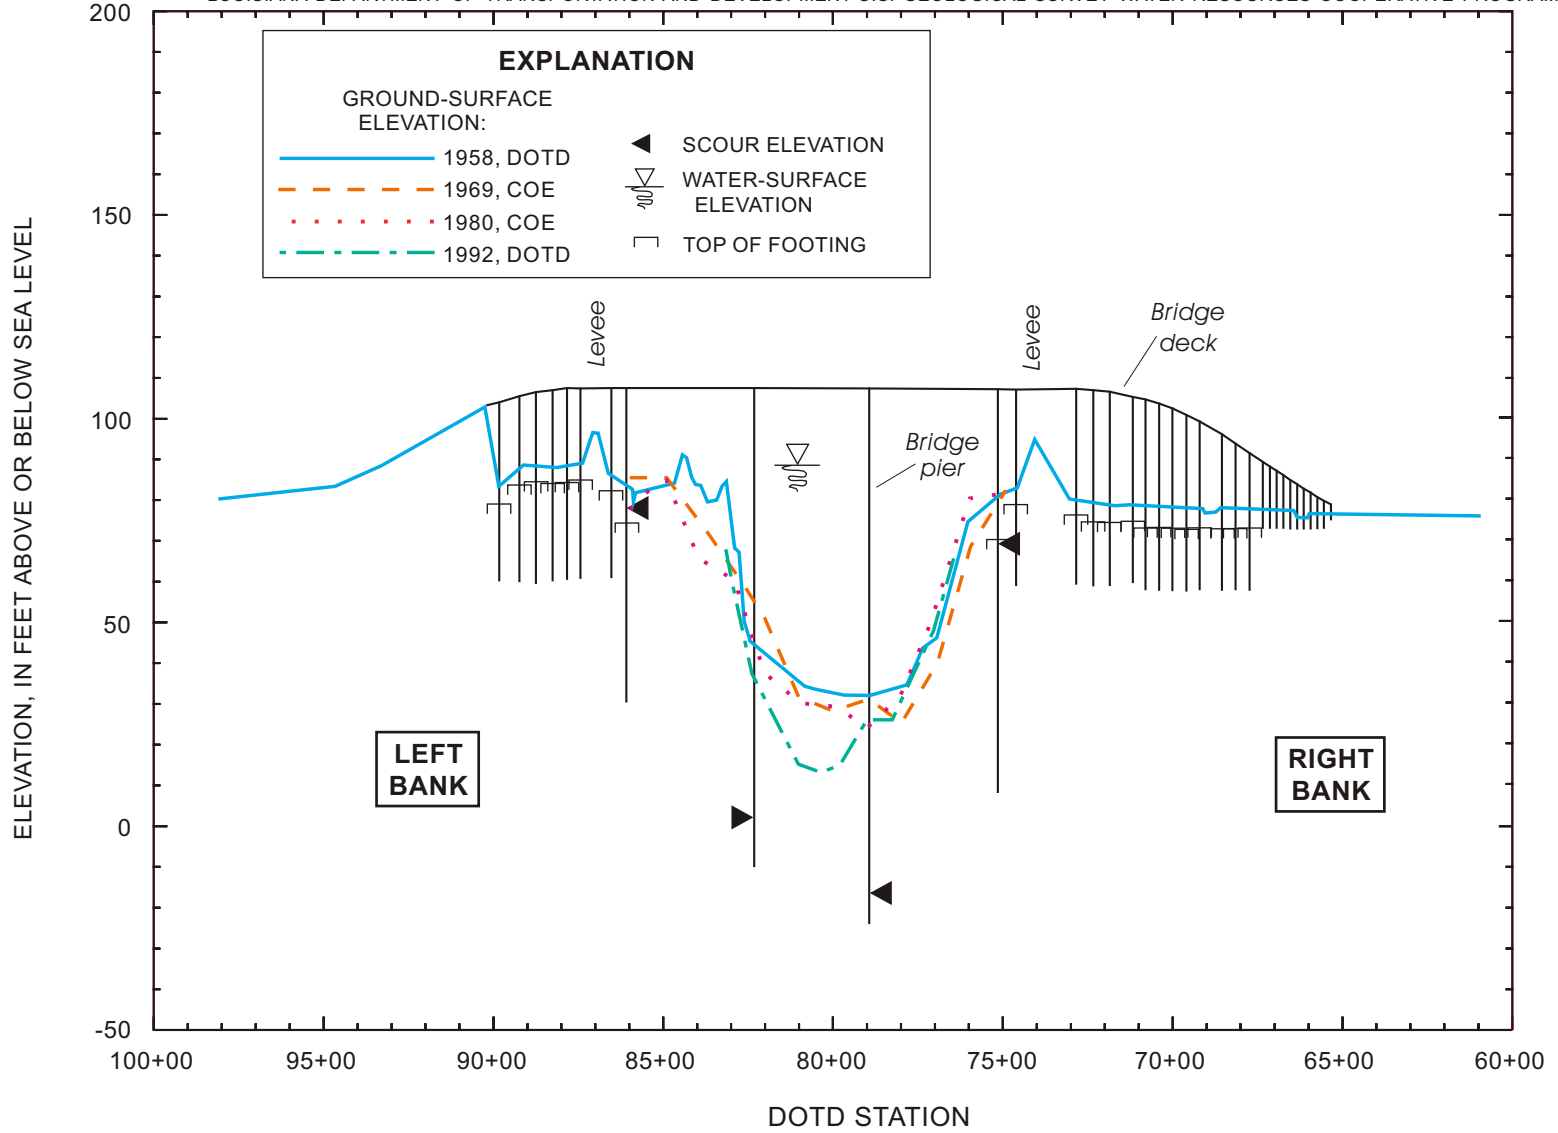
Figure 9. Comparative cross sections and pier-scour estimates at U.S. Highway 165 crossing at Alexandria, Louisiana (revised 1999).

Hydrographic surveys of 1969 and 1980 at the U.S. Hwy. 165 bridge do not indicate any substantial trends or changes in the channel. The lowest channel-bed elevations occur at the right main pier of the bridge. The differences indicated between the COE and DOTD surveys of 1980 can be attributed to minor differences where the cross section was measured. The DOTD survey is performed at the highway crossing, and the COE cross section is a surveyed cross section nearest to the bridge location. The channel-bed elevations from the surveys ranged from 21 to 25 ft above sea level. The top of the footing at the right main pier is 18 ft above sea level. The layer of bed material covering the right main pier footing appears stable from the hydrographic information, but the scour estimates from the previous paragraph indicate the potential removal of this material, exposing the footing. Aerial photographs taken in 1977 and 1987 (figs. 10 and 11) show no substantial changes of alignment.

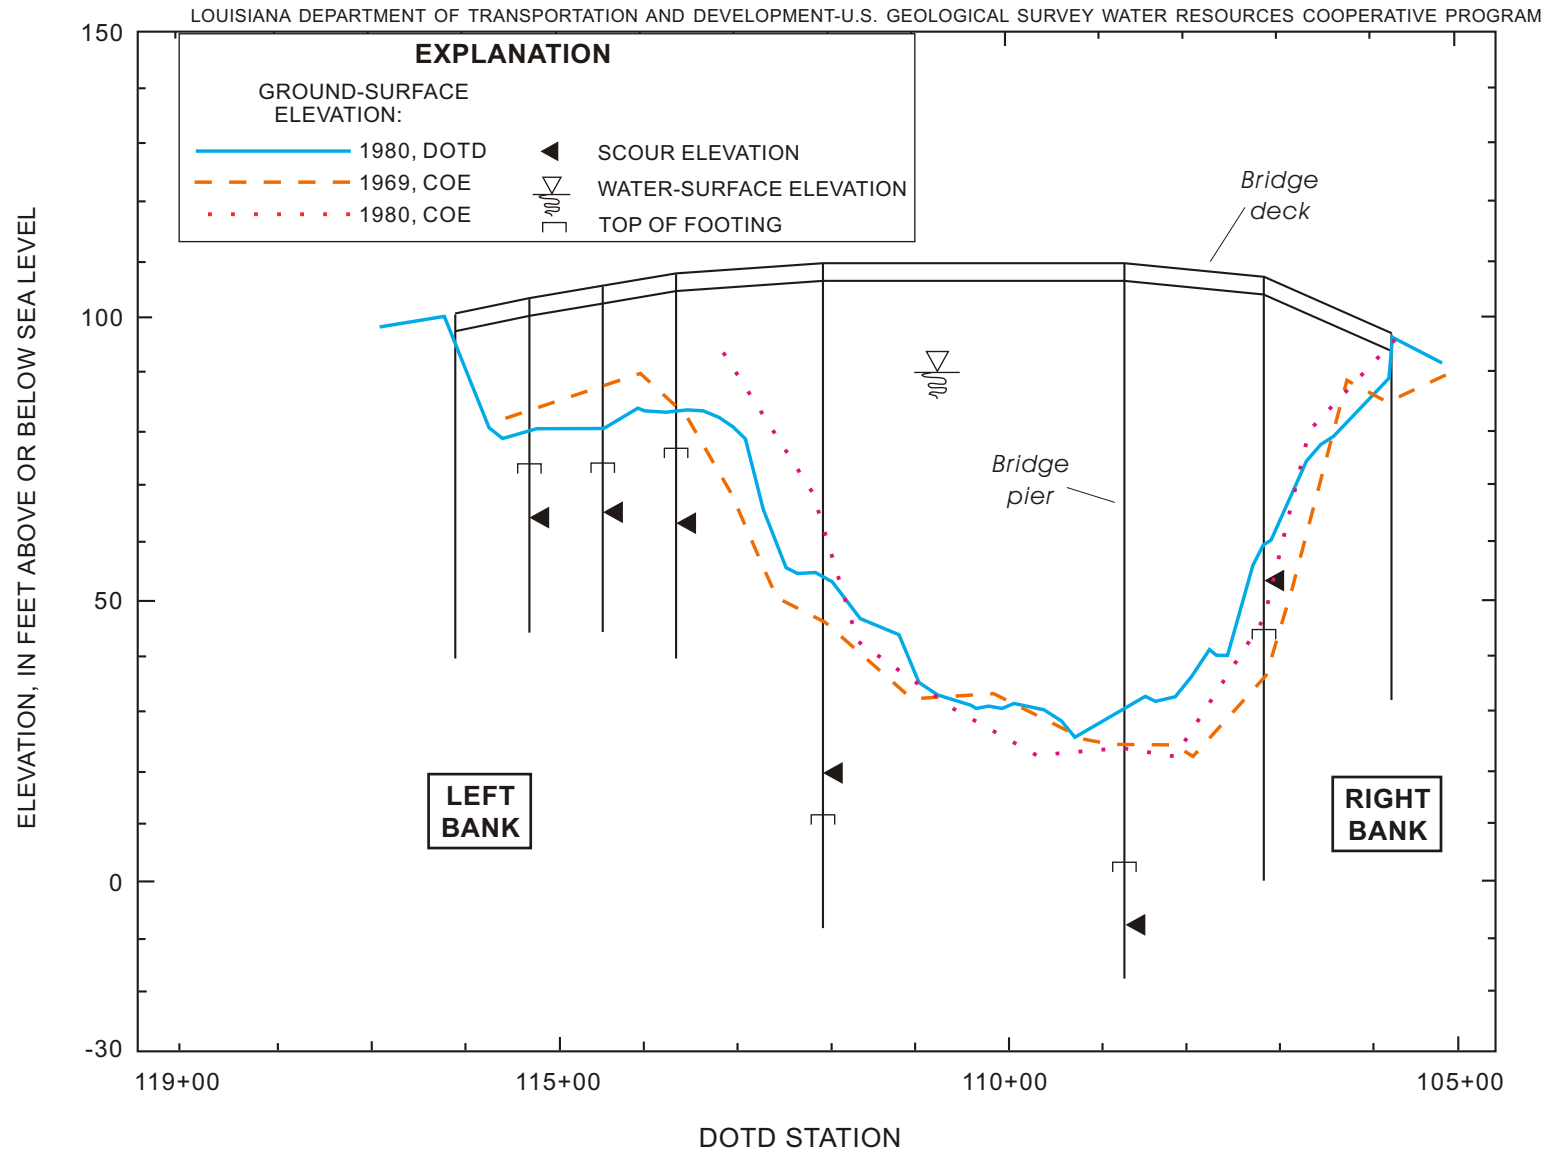
Figure 12. Comparative cross sections and pier-scour estimates at U.S. Highway 71 crossing at Alexandria, Louisiana.

To evaluate pier scour at U.S. Hwy. 71, values for y_1 at each pier were based on the DOTD hydrographic survey of 1992. The cross section represented by the 1992 DOTD survey indicates decreased channel-bed elevations near the right main pier (fig. 12). Values for K_1=1.0, K_2=1.0, and K_3=1.1 were based on DOTD bridge plans and recommendations presented by Richardson and others (1993, p. 39-40). The Froude number at the pier location is based upon the value of velocity, which was computed using WSPRO.

The hydrographic surveys of 1968 and 1980 show little dynamic activity of the river bed (fig. 12); however, the DOTD hydrographic survey of 1992 indicates a deepening and migration of the thalweg toward the right bank. This most recent survey indicates channel-bed elevations are below the top of the right-bank main-pier footing. Based on this information, the pier is at a higher risk of failure than the other piers at this site. Aerial photographs taken in 1977 and 1987 (figs. 13 and 14) were taken at low-water conditions and indicate no alignment changes.

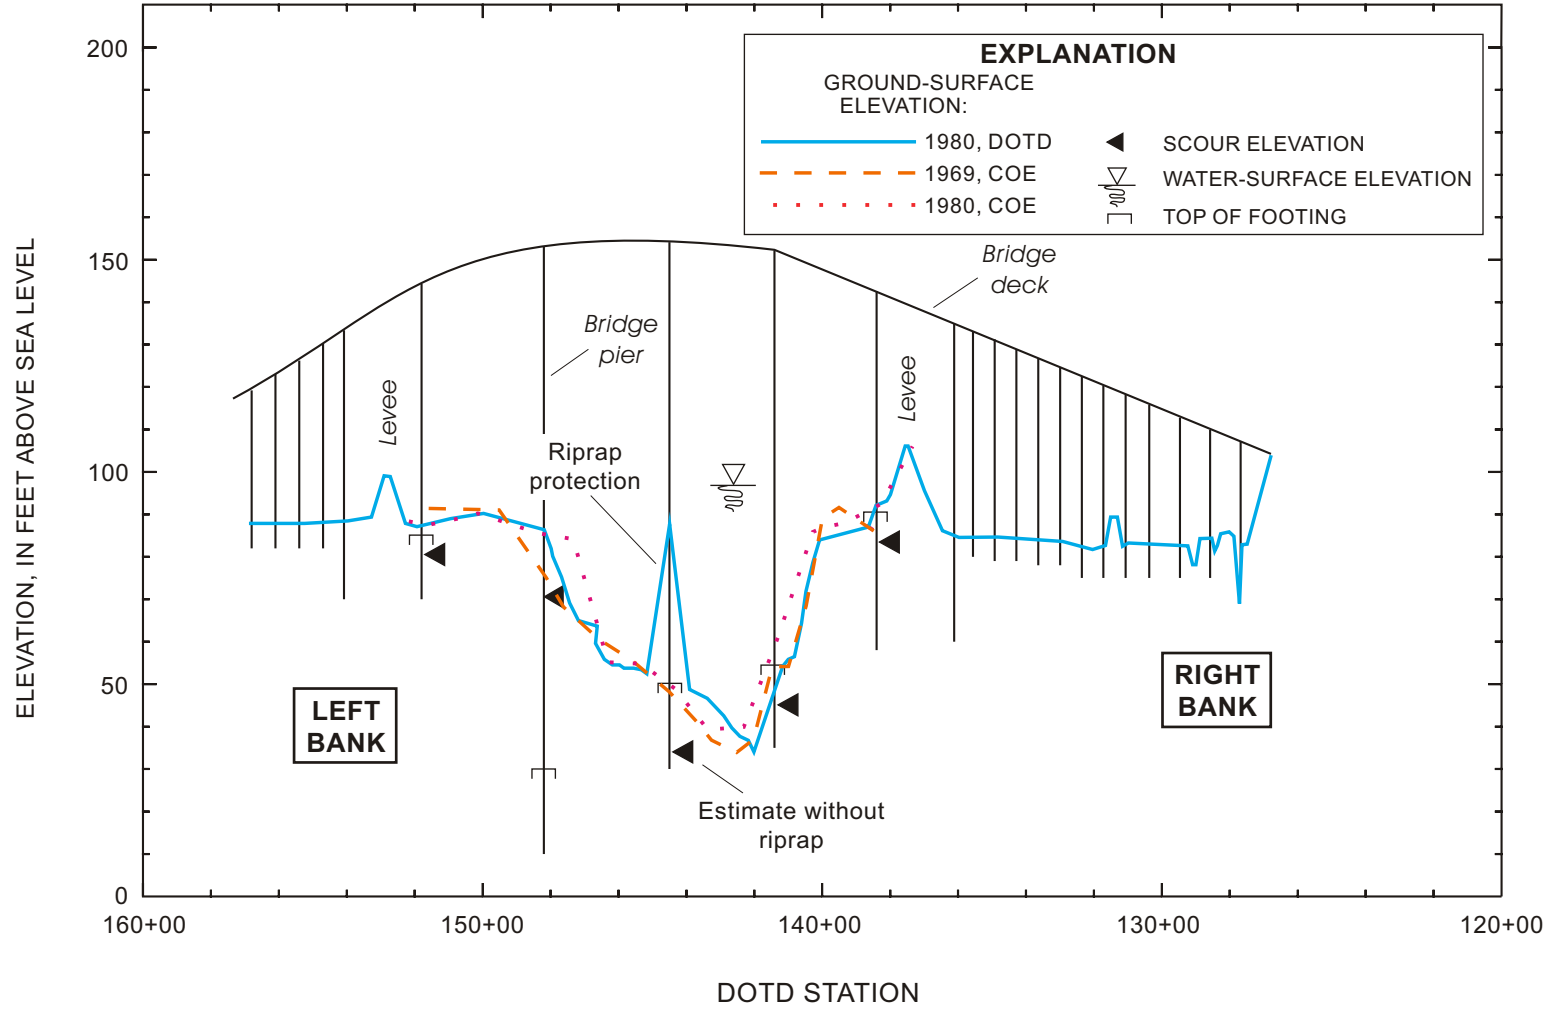
Figure 15. Comparative cross sections and pier-scour estimates at Louisiana Highway 8 crossing at Boyce, Louisiana (revised 1999).

For evaluation of pier scour at La. Hwy. 8, values for y_1 at each pier were based on the COE hydrographic survey of 1969. The cross section represented by the 1969 survey represents a fairly uniform section and represents the lowest elevations for sections based on the historical cross-section information at the site (fig. 15). Other surveys at this site indicate minor changes in the minimum channel-bed elevation, but with no substantial movement of the thalweg. Values for K_1=1.0, K_2=1.0, and K_3=1.1 were based on DOTD bridge plans and recommendations presented by Richardson and others (1993, p. 39-40). The Froude number at the pier location is based upon the value of velocity, which was computed using WSPRO (table 5). The maximum computed scour depth was 15.5 ft for the pier at DOTD station 144+50. The elevation of the bed of the computed scour hole is approximately 29 ft above sea level. The two piers in the main channel at DOTD stations 141+40 and 144+50 are protected from scouring by stone riprap according to the design plans. The Colorado State University pier-scour equation recommended by Richardson and others (1991, 1993) is for cohesionless sand-bed streams, not for locations armored with large stone material such as riprap. For this reason, estimates of pier scour for locations with riprap protection are shown for informational purposes only. For the pier at DOTD station 144+50, the riprap is part of a rock dike, which is visible from aerial photographs (figs. 16 and 17). The riprap protection for the pier at DOTD station 141+50 is unconfirmed by information collected for this evaluation, and the presence of the riprap material is assumed, based solely on the bridge plan drawings.

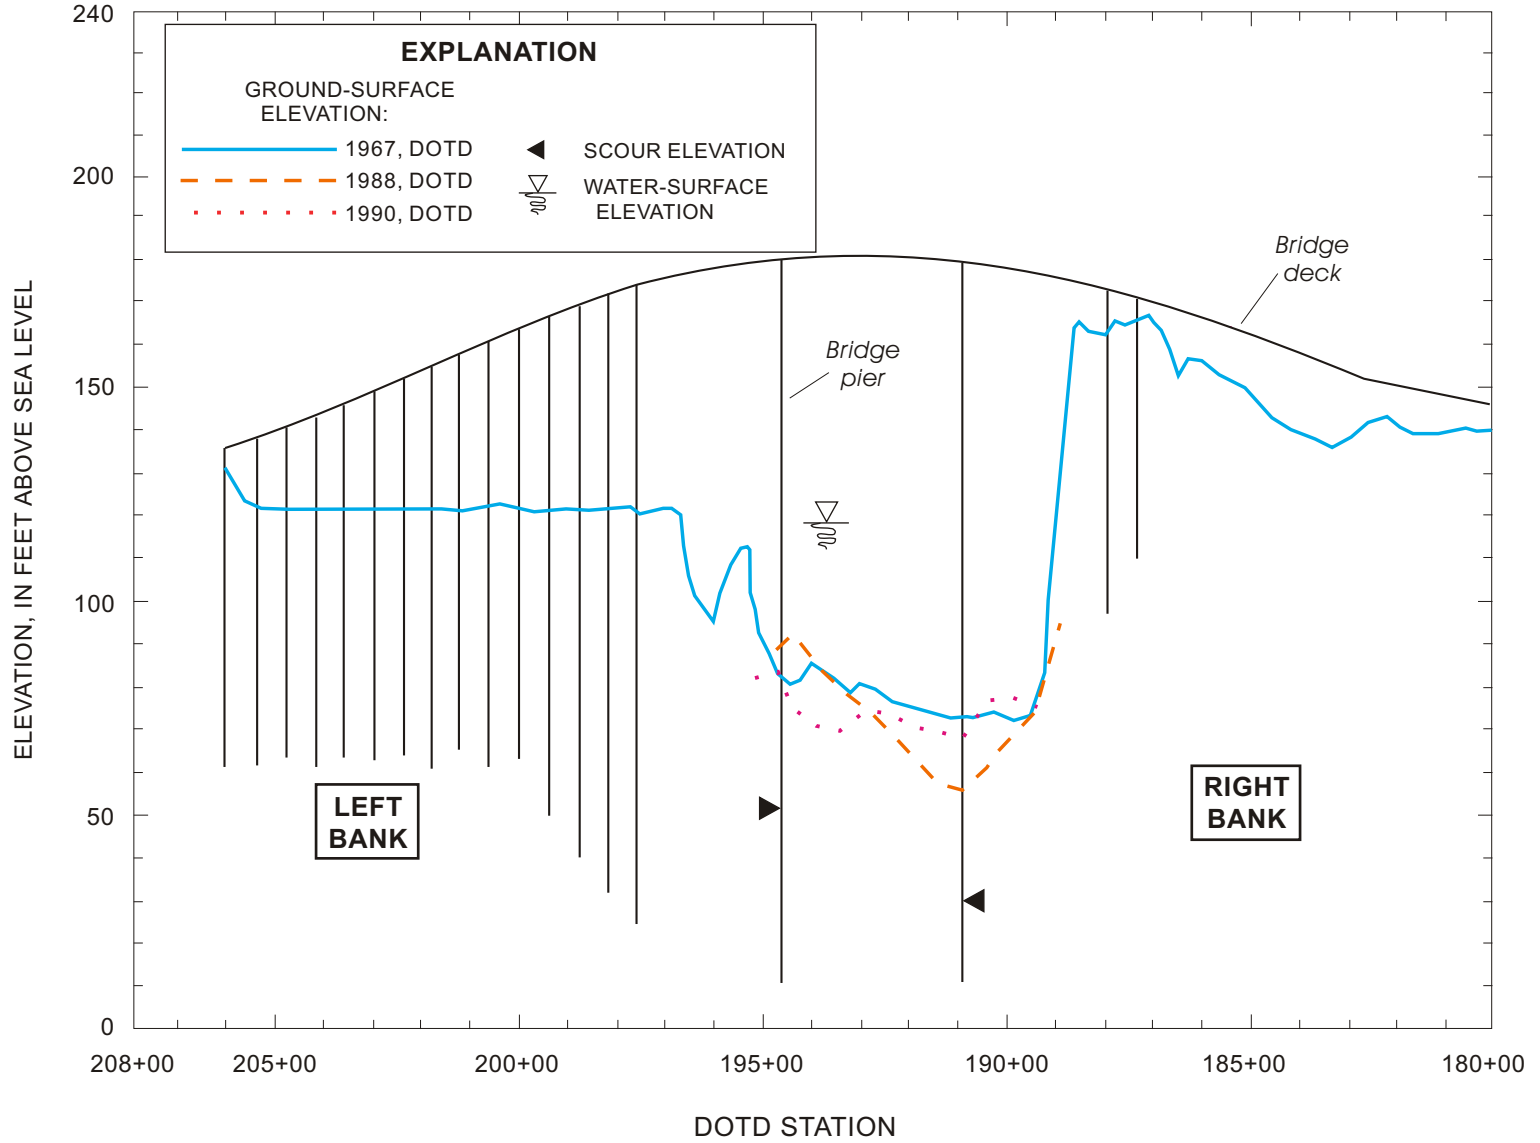
Figure 18. Comparative cross sections and pier-scour estimates at Louisiana Highway 6 crossing at Grand Ecore, Louisiana (revised 1999).

For evaluation of pier scour at La. Hwy. 6, values for y_1 at each pier were based on the DOTD hydrographic survey of 1990. The cross section represented by this survey represents a fairly uniform section, and generally agrees with the section from the survey of 1967 (fig. 18). The survey of 1988 indicates lowering of the minimum channel-bed elevation, but no significant lateral movement of the thalweg. If those conditions reoccur periodically, the estimate of scour may need reevaluation. Values for K_1=1.0, K_2=1.0, and K_3=1.1 were based on DOTD bridge plans and recommendations presented by Richardson and others (1993, p. 39-40). The Froude number at the pier location is based upon the value of velocity, which was computed using WSPRO.

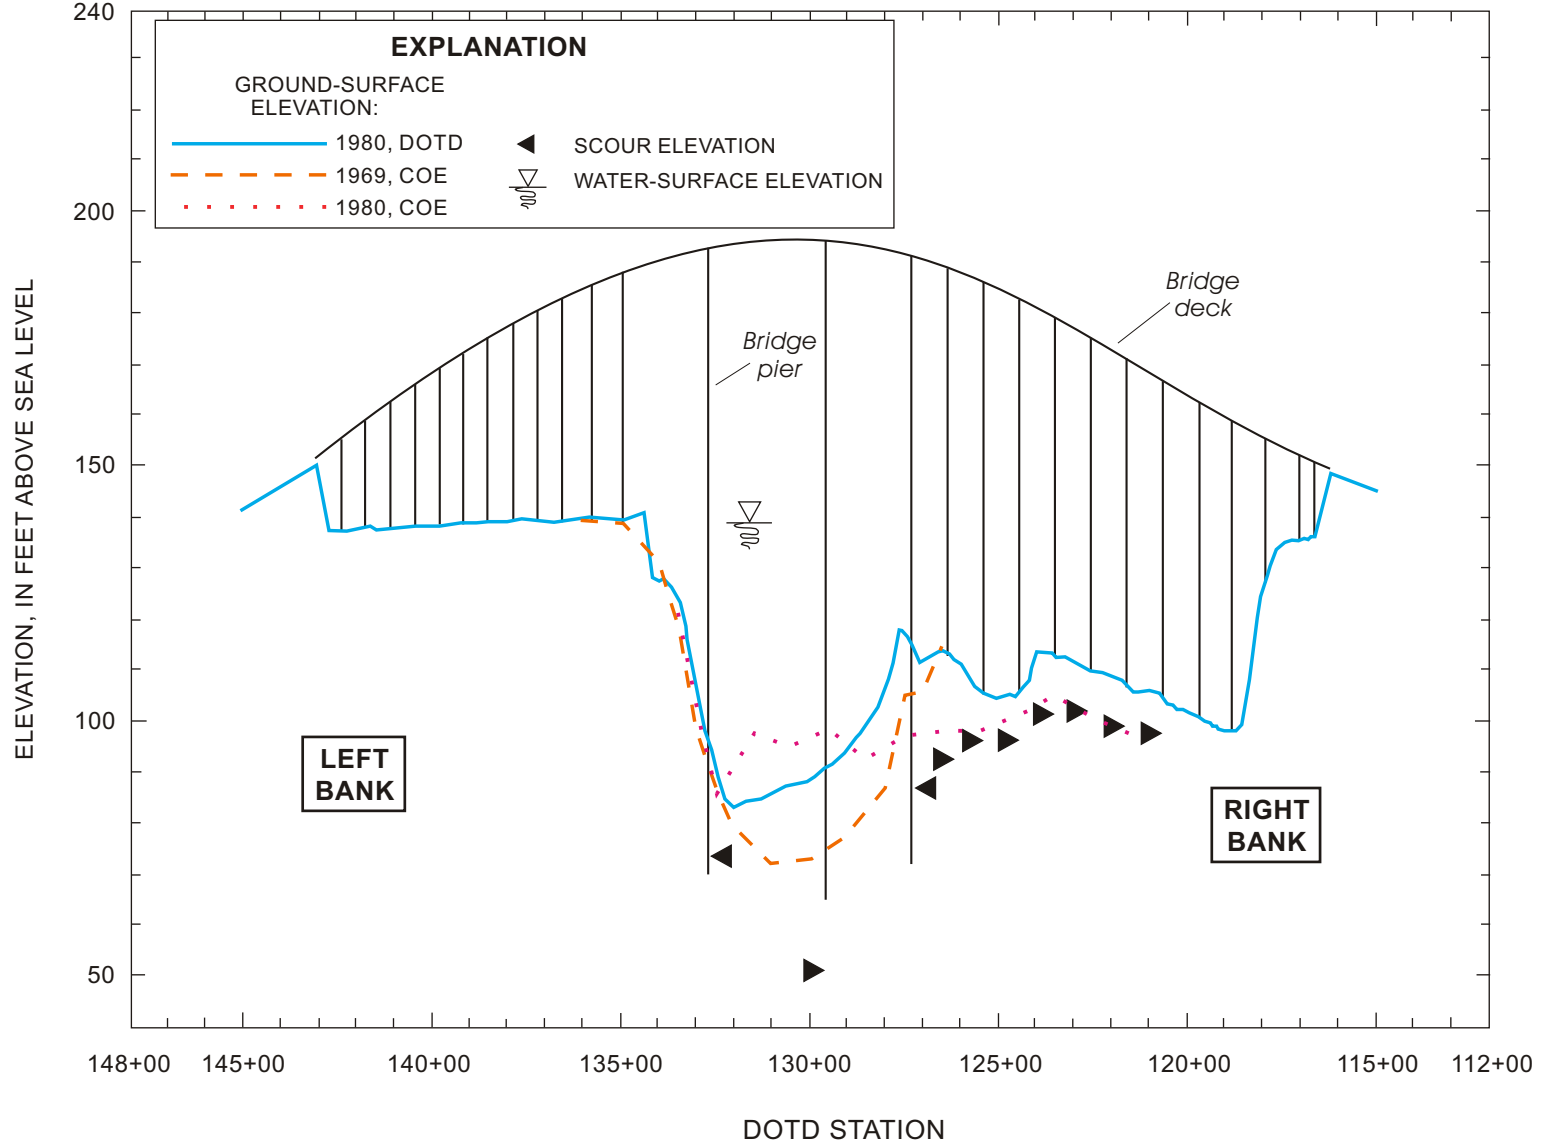
Figure 21. Comparative cross sections and pier-scour estimates at U.S. Highway 84 crossing at Coushatta, Louisiana.

For evaluation of pier scour at U.S. Hwy. 84, values for y_1 at each pier were based on the COE hydrographic survey of 1969. The cross section represented by this survey represents the lowest channel-bed elevations of the cross sections shown in figure 21. Values for $K_1=1.0$, $K_2,=1.0$, and $K_3=1.1$ were based on DOTD bridge plans and recommendations presented by Richardson and others (1993, p. 39-40). The Froude number at the pier location is based upon the value of velocity, which was computed using WSPRO.

The cross sections at U.S. Hwy. 84 shown in figure 21 indicate several geometric conditions. The cross sections from the 1980 surveys by DOTD and COE data differ substantially. This difference is most likely due to relatively slight differences in the location where the cross section was surveyed. The DOTD cross section was surveyed exactly at the bridge location. The COE survey cross section is the cross section from the hydrographic survey that was nearest the bridge. The COE cross sections surveyed in 1969 and 1980 differ in longitudinal location on the river by about 500 ft. The 1969 cross section was surveyed at river mile 220.6, which is at the highway crossing and the 1980 cross section was surveyed at river mile 220.7. This difference in geometry does not indicate changing bed conditions at the bridge site, but it does indicate the difference in channel geometry along a very short reach near the bridge. One condition that shows some stability is the steeply sloping left bank. The location and slope of the left bank are identical for all three surveys shown. Some insight into the variability on the right bank can be emphasized from aerial photographs taken in 1977 and 1987. The photograph taken in 1977 (fig. 22) indicates erosion along the right bank, immediately downstream of the bridge. This evidence of erosion does not appear in the photograph taken in 1987 (fig. 23). This later photograph indicates a shift in flow towards the left bank. Established vegetation can be observed in the 1987 photograph in the areas where bank erosion was observed in the 1977 photograph. Vegetation also has become established in the areas of deposition on the right bank, upstream of the highway crossing.

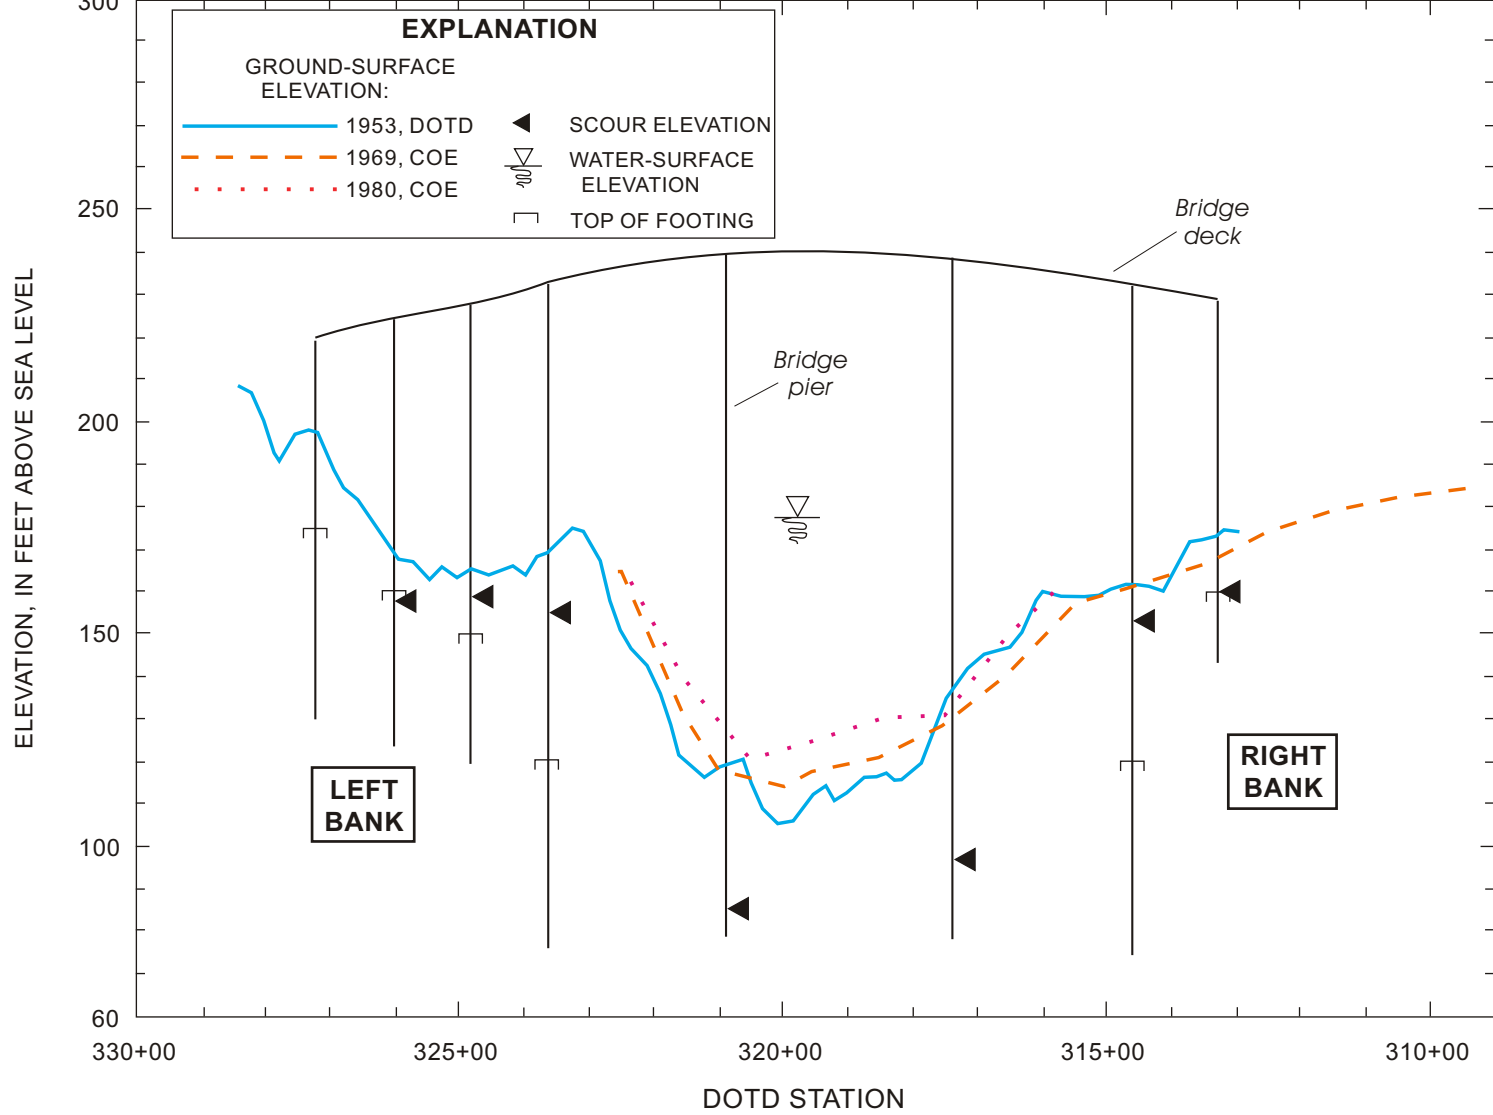
Figure 30. Comparative cross sections and pier-scour estimates at Interstate Highway 20 crossing at Shreveport, Louisiana.

For evaluation of pier scour at Interstate Hwy. 20, values for y_1 at each pier were based on the COE hydrographic survey of 1980. The cross section resembles the channel-bed elevations recorded in 1953 and 1969, but is the highest of the three cross sections shown in figure 30. The right overbank pier has an estimated scour depth of 6.3 ft, which corresponds to a bed elevation of 160 ft above sea level (table 8). This elevation is equal to the pile-footing cap elevation. The pier at DOTD station 314+60 has an estimated scour depth of 10.3 ft, which corresponds to a bed elevation of 152 ft above sea level. This elevation is well above the pile-footing cap. The main piers at DOTD stations 317+25 and 320+85 have the largest predicted scour depths of approximately 34.7 and 38.0 ft. The minimum predicted channel-bed elevation from pier scour is 82 ft above sea level for the pier at DOTD station 320+85. Pier-scour computations for left overbank piers at DOTD stations 323+60, 324+80, and 326+00 have estimated scour depths of 10.3, 6.5, and 6.5 ft. The scour estimate at DOTD station 326+00 indicates that the pile cap is slightly exposed. Computations outlined by Richardson and others (1991, 1993) for exposed footings were used to evaluate the scour potential for the exposed pile cap. The resulting scour depth was not substantially different from the initial pier scour computation.

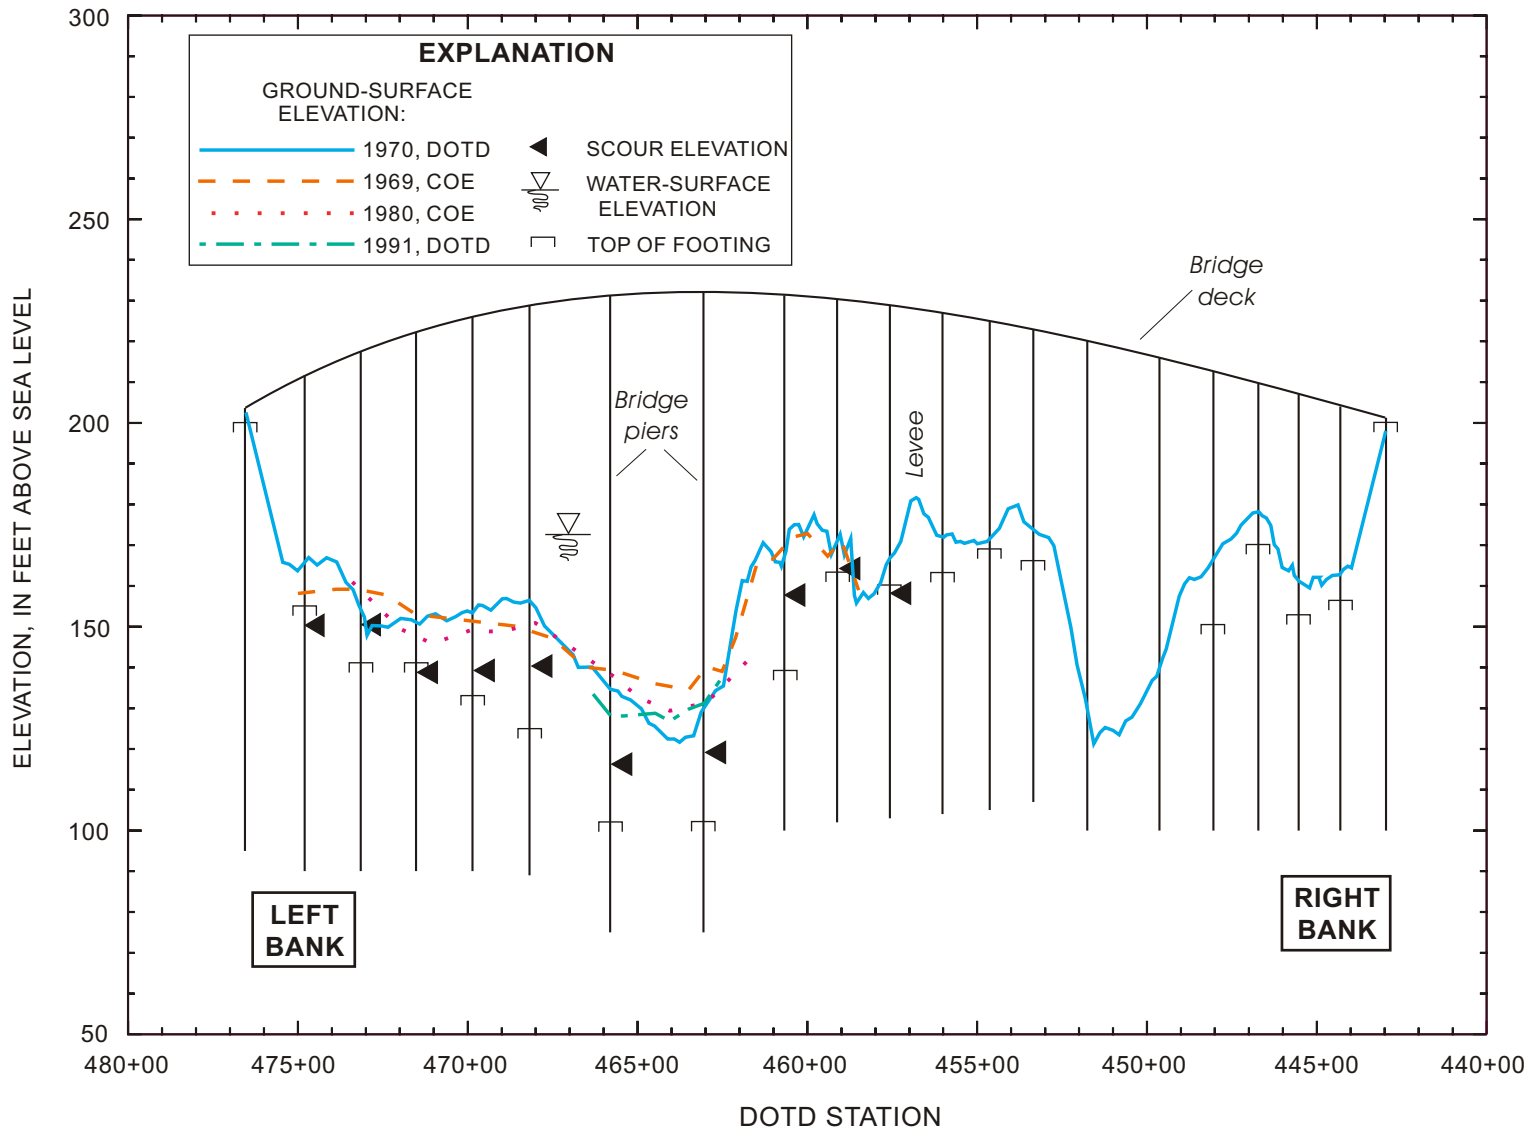
Figure 36. Comparative cross sections and pier-scour estimates at Interstate Highway 220 crossing at Shreveport, Louisiana (revised 1999).

For evaluation of pier scour at Interstate Hwy. 220, values for y_1 at each pier were based on the DOTD hydrographic survey of 1991. The cross section represented by this survey represents a fairly uniform section (fig. 36). Other surveys at this site indicate little movement of the thalweg. Values for K_1=1.0, K_2=1.0, and K_3=1.1 were based on DOTD bridge plans and recommendations presented by Richardson and others (1993, p. 39-40). The Froude number at the pier location was based upon the value of velocity, which was computed using WSPRO.

Cross-section information exists for the years 1969, 1970, 1980, and 1991. The elevation of the thalweg changes about 10 ft among the surveys. Indication of any lateral movement or shifting of the channel is not significant based on the survey information. Some of the variation in channel-bed elevations may be the response of the stream bed to seasonal variations in discharge. The right bank is the steepest of the two stream banks and is the outside bank of the curve in the river to the left. Although this bank is relatively steeply sloping and is the outside bank of a curve, the cross-section information indicates that it is stable and shows no erosion. Figures 37 and 38 are aerial photographs of the bridge crossing for 1977 and 1987. Timber river-training works are visible on the right bank in the photographs. This timber piling may have contributed to the stability of the right bank.

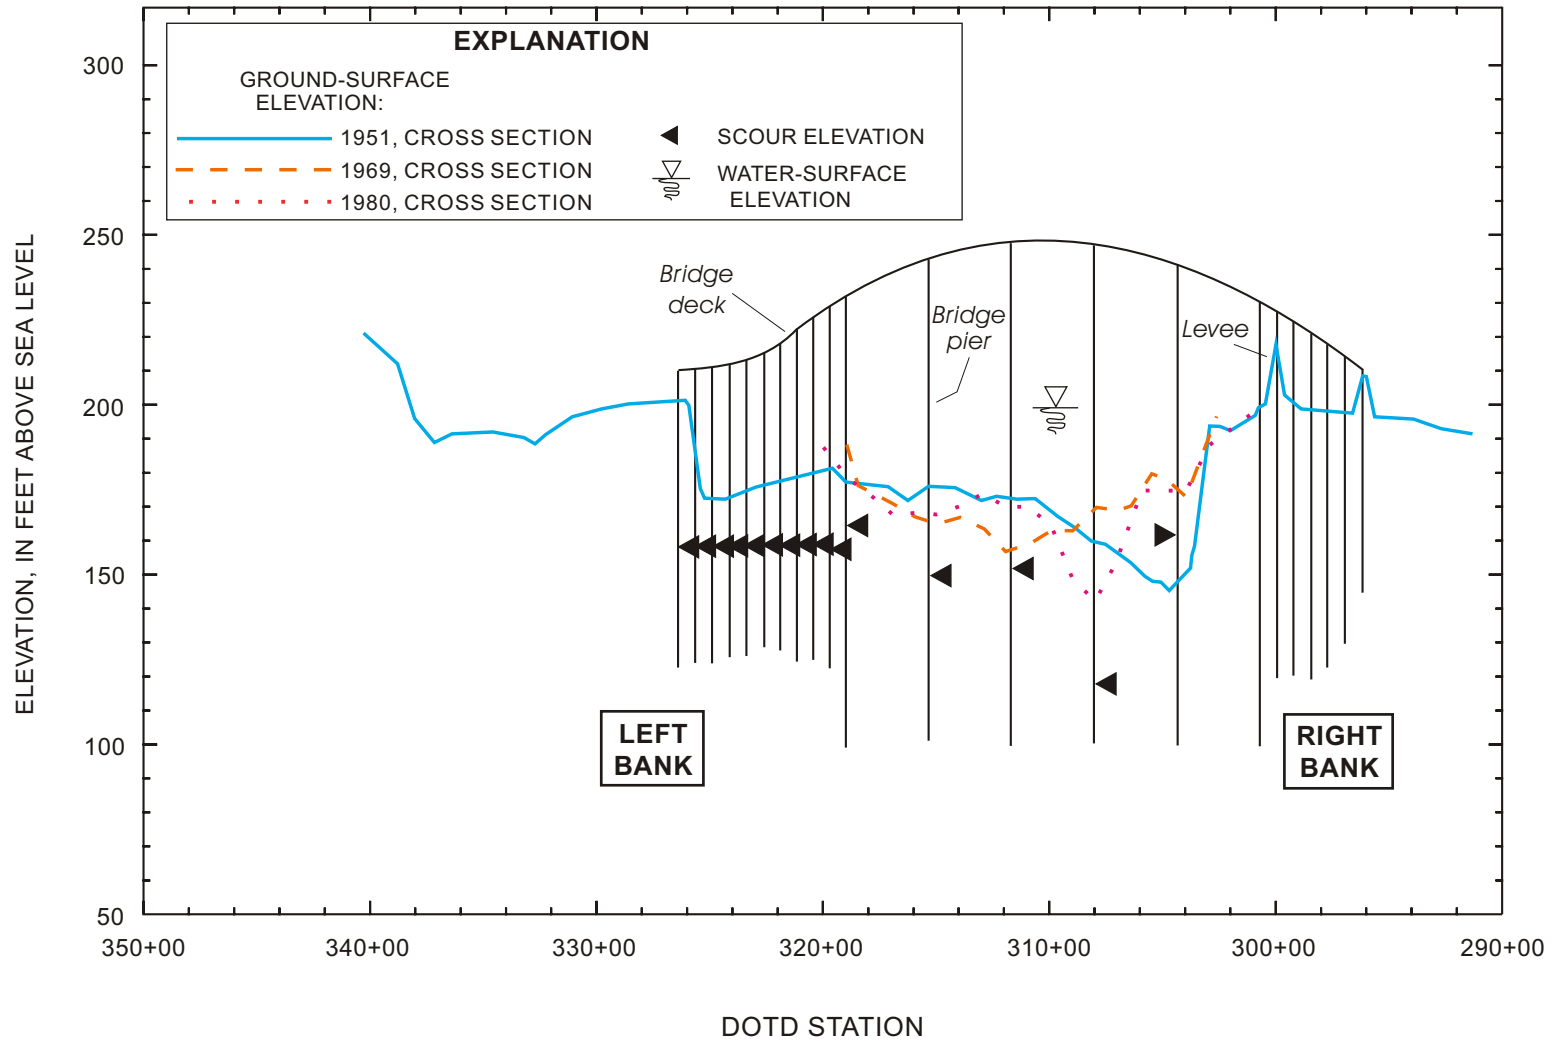
Figure 39. Comparative cross sections and pier-scour estimates at Louisiana Highway 2 crossing near Hosston, Louisiana (revised 1999).

The maximum computed scour depth was approximately 20.8 ft for the pier at DOTD station 308+00 (table 10). The channel-bed elevation of the computed scour hole is about 122 ft above sea level. The elevation of the pile-footing cap for this pier is about 125 ft above sea level. Potential scour for the piers at DOTD stations 304+34 and 308+00 may approach the maximum computed scour for this bridge. Although this depth of scour is greater than indicated from the computations shown for DOTD station 304+34, it should be considered because of the observed shifting of the channel at this bridge. For piers landward of DOTD station 319+00, the estimated depth of scour is 12.4 ft (fig. 39, table 10).

Cross-section information is shown in figure 39 for the years 1951, 1969, and 1980. These surveys indicate significant dynamic activity of the channel bed at this location. It should be noted that, although prominent bed activity is documented among the surveys, similar activity could have occurred between the surveys. Of all the surveys shown in figure 39, no two surveys replicate each other in any reasonable manner. Surveys not shown in figure 39, for the purpose of clarity, show the thalweg on the left bank in 1949 shifted toward the right bank in 1950, then further to the right in 1951. The 1969 survey documents that the thalweg had moved near center channel and a relatively uniform cross section existed. The survey of 1980 documents movement toward the right bank again, near the observed location of the thalweg in 1950. All of the thalweg elevations observed near the right bank were about 140 ft above sea level, which is about 15 ft above the pile-footing cap for the bridge-support piers. A comparison of aerial photographs taken in 1977 and 1987 (figs. 40 and 41) shows the main channel is on the right side of the river during low water. It can also be observed that, during this time period between the two photographs, vegetation has become more established in the area separating the main channel and the minor channel on the left bank.

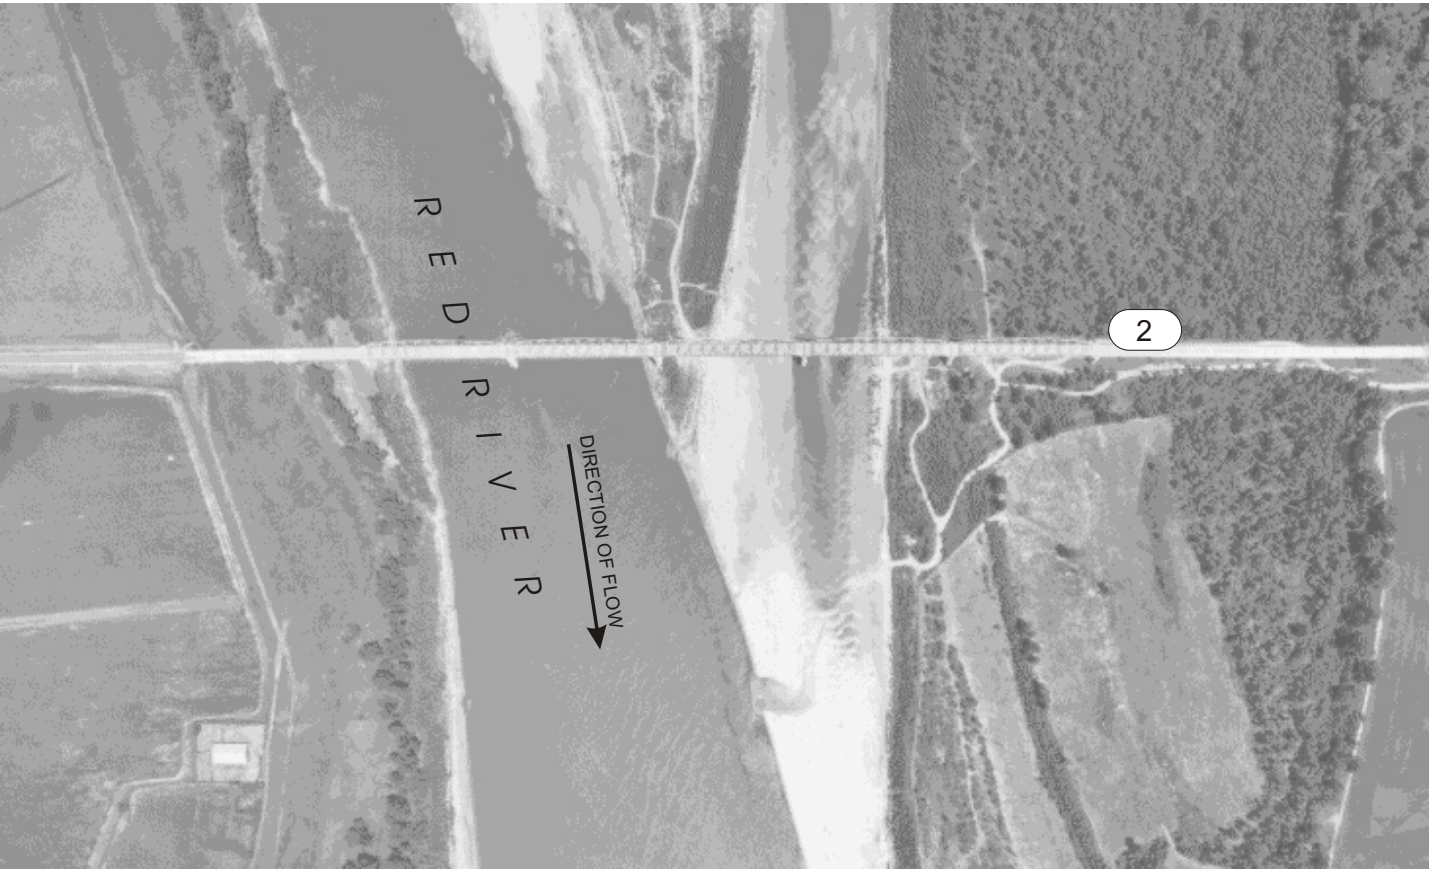
Figure 40. Aerial photograph of the Louisiana Highway 2 crossing of the Red River near Hosston, Louisiana, August 9, 1977.

The greatest pier-scour estimate was for Interstate Highway 20 near Shreveport where 38 feet was estimated at the pier at Louisiana Department of Transportation and Development station 320+85. The greatest channel-bed dynamics was observed at Louisiana Highway 2 near Hosston where thalweg elevations 21 feet deeper than the ambient bed moved laterally across the cross section.
